# Structural and geotechnical impacts of surface rupture on highway structures during recent earthquakes in Turkey

A. Pamuk<sup>a,\*</sup>, E. Kalkan<sup>b</sup>, H.I. Ling<sup>a</sup>

*Keywords:* Bridge; Kocaeli earthquake; Duzce earthquake; Seismic hazard; Retrofitting; Fault rupture; Arifiye Overpass; Mechanically stabilized earth wall

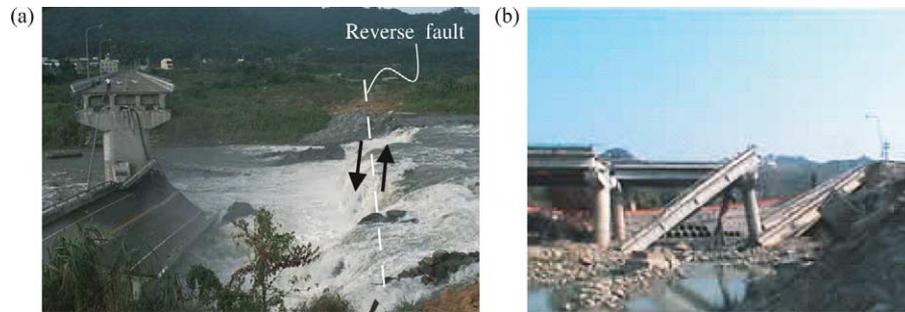
[1]. The Bei-Feng Bridge (Fig. 1(a)) experienced a vertical ground movement of about 5–6 m which resulted in the collapse of its three spans. Similar damage was observed in a skewed bridge, the Shi-Wei Bridge (Fig. 1(b)), when the fault imposed large deformations on the southern abutment [2,4]. These are the typical examples of surface ruptures causing detrimental effects on highway facilities. During Turkey's earthquakes, several bridges were damaged significantly due to similar phenomena.

Fig. 1. Collapsed bridges in Taiwan due to fault rupture: (a) Bei-Fung Bridge [2]; (b) Shi-Wei Bridge [3].

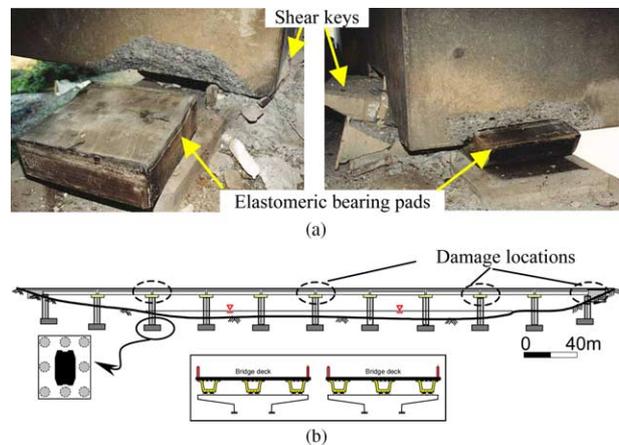
Fig. 4. Dislodgment of bearing systems at Sakarya Viaduct: (a) damaged bearing pads and shear keys [7]; (b) details of viaduct.

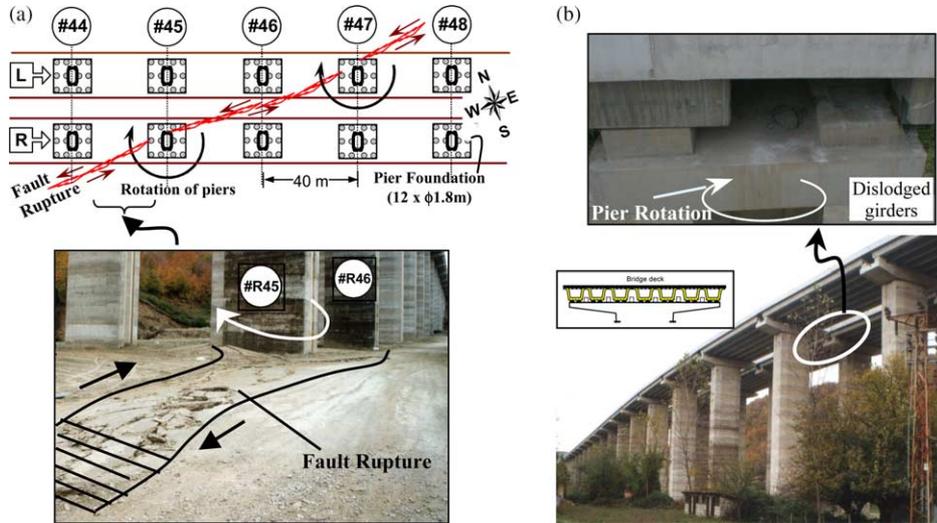
Surface rupture crossed the bridge piers of the Bolu Viaduct, with a right lateral fault offset of more than 1.50 m (Fig. 5). This viaduct was composed of a pair of independent parallel bridge decks (each 40 m long and 17.5 m wide) supported by 60 piers, which makes it the longest (2.5 km in length) bridge on the TEM. It was still under construction during the Duzce earthquake. Although the bridge decks were equipped with seismic dampers, bridge girders could not accommodate the substantial displacements imposed by the main shock and the tectonic deformation. Surface faulting forced the piers to rotate as the rupture crossed the viaduct (Fig. 5(a)), resulting in damaged shear keys, bearing supports and dampers, and the dislodgement of girders (Fig. 5(b)).

Fig. 5. Performance of Bolu Viaduct during Duzce earthquake: (a) piers traversed by surface fault rupture; (b) superstructural damage.

Another possible solution to prevent span failures is the installation of cable restrainers across deck joints. The restrainers utilized at expansion joints on the decks of the Bolu Viaduct prevented end girders from dislodging off of

their supports during the Duzce earthquake [14]. Fig. 10(b) shows a typical hinge joint (cable) restrainer that has been installed to prevent excessive longitudinal joint separations in this viaduct. Such retrofitting measures were also shown to be effective during the 1989 Loma Prieta earthquake [16]. These are all applications commonly used to avoid catastrophic failures in highway bridges.

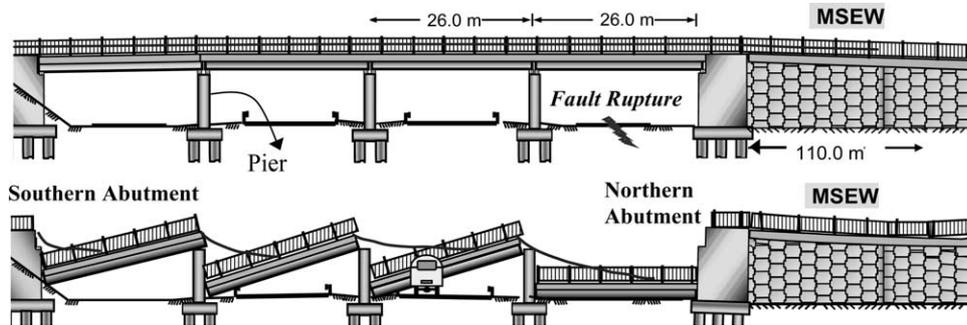
Fig. 6. Overpass bridge at Arifiye and mechanical stabilized approach fill walls before and after the Kocaeli earthquake.

Despite the lack of acceleration data at the bridge site, the permanent ground displacements due to surface fault rupture was clearly measured at Arifiye. Such deformations resulted in unseating of the bridge girders that was followed by a total collapse of the bridge spans as well as damage to the MSEW of the reinforced approach fill. The structural

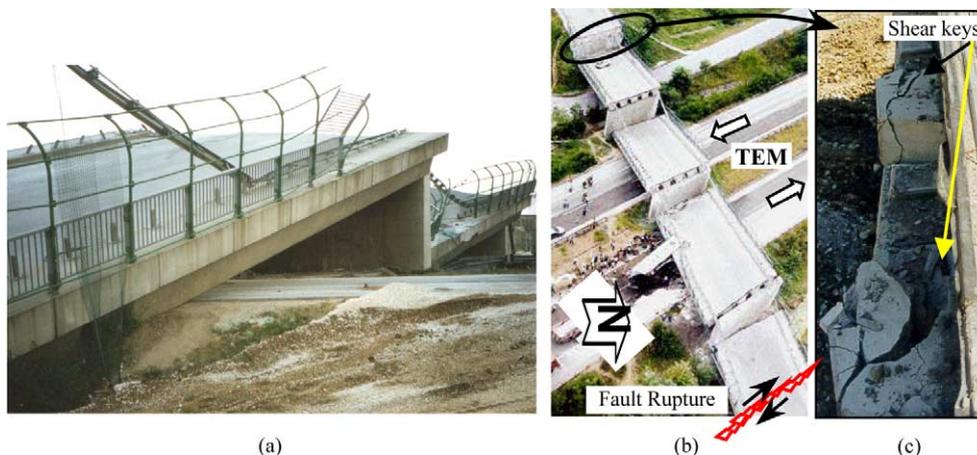
collapse of Arifiye Overpass revealed the following deficiencies. The large right-lateral fault traversing at Arifiye caused more than 1 m of longitudinal displacement under the northern span. Such permanent deformation was much greater than the existing seating length of the deck girders. Tilting of bridge piers located in the north direction and close to surface rupture (Fig. 7) exacerbated the dislodging of girders from their elastomeric bearing supports. Insufficient seating length of deck girders and elastomeric bearings, as well as dysfunctional shear keys (Fig. 9) triggered the catastrophic failure of the bridge span.

The observed structural damage of the Arifiye Overpass is typical such that other TEM bridges also suffered similar damage due to the shear key failures. These shear keys were not designed or constructed sufficiently against large transverse movement. In fact, had the shear keys been able to provide tolerable lateral restraining to those TEM bridges and overpasses, much of the associated damage could have been eliminated [14]. The collapse of Arifiye Overpass further indicates that bridges with skewed geometry are more vulnerable to support excessive movements, which may cause significant damage to their supports and bearing systems. For such structures, extended seating width provides a reasonable solution to avoid deck failures, particularly if the fault rupture has the potential to intersect with bridge structures.

Fig. 9. Arifiye Overpass traversed by surface fault rupture: (a) side view; (b) aerial view [13]; (c) damaged shear keys in the southern bridge abutment.

Today many bridges along the TEM, especially those located in the vicinity of the Istanbul Metropolitan Area, are threatened by the North Anatolian Fault (NAF) and consequent surface ruptures. Strong earthquakes in this area may replicate the observed damage at Arifiye. For this specific reason, the seating length of the existing bridges has been widened by mounting additional L-shaped supports (Fig. 10(a)), and by redesigning elastomeric bearings and shear keys [9,14].

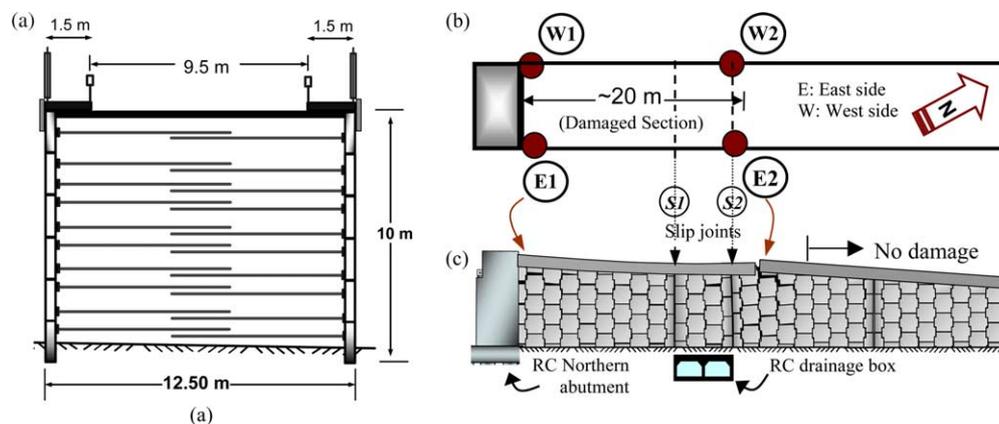
Fig. 11. Schematic of reinforced bridge approach fill of Arifiye Overpass: (a) cross section; (b) plan view of damage-concentrated locations; (c) damaged eastern wall face.

to be the main source of damage to the reinforced walls of the approach ramp. The deformation on the main fault rupture extended through the RC culvert under the reinforced ramp (Fig. 11(c)). Cracks caused by vertical deformation were clearly observed on the asphalt-covered side roads, especially on the western side of the ramp (Fig. 14). It should also be pointed out that the final permanent ground deformation in this section possibly included the settlement due to soil densification, in addition to the subsidence from the fault rupture. However, the undamaged section of the wall did not exhibit any settlement due to earthquake shaking, indicating that the majority of the ground failure under the MSEW was from the nearby tectonic activity.

The greatest disturbance to the wall faces was concentrated at higher elevations above the RC drainage box culvert. Because the vertical displacement in the eastern wall face was larger than the other side, the approach ramp tilted eastward in the cross section, especially at the location above the drainage box culvert. This tilting was probably due to the presence of the rigid culvert that prevented the ramp from moving with its foundation soil. The walls could not uniformly accommodate the underlying fault-induced ground deformations and cyclic-induced soil densification (i.e. ground settlement). The tilting in the cross section resulted in different damage states above the culvert at E2 and W2 such that the western wall ‘buckled’ in the vicinity of W2, whereas the eastern wall face was stretched outward (Figs. 13(b) and 14(b)). The buckled side increased compression on the facing panels at W2 and forced the panels to displace at this location. The largest damage in the reinforced walls was observed on the eastern side at E1. At this location, the wall was displaced both vertically and horizontally for about 25–30 cm. The displacements here were so large that they exceeded allowable design limitations for independent panel movement. Thus, the panels could not accommodate the ground deformations leading to the large separation and cracking of the panels. However, the facing panel connections with the metallic reinforcements did not fail, and their flexible joints allowed large displacements and differential settlements.

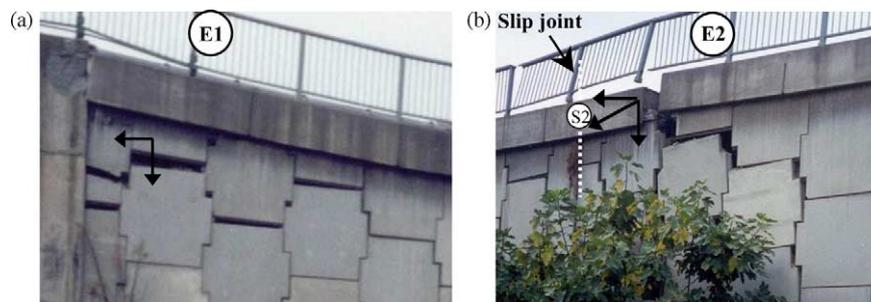
At E1 and W1 (Figs. 13(a) and 14(a)), the facing panels interacted with the pile supported bridge abutment. The damage states at both locations were also different. At E1,

Fig. 13. Damage on the eastern MSEW face: (a) E1; (b) E2 (courtesy of M. Ozbakir).

the vertical ground deformation was so large that the flexible wall face was forced to displace vertically and longitudinally (i.e. along the wall). The movement in the longitudinal direction was prevented by the rigid abutment at the top of the wall that caused large panel separations and cracks, but no damage was observed at the bottom. At W1, the vertical ground deformation was not large compared to E1, however, a gap (i.e. panel separation) occurred between the panels and the abutment as shown in Fig. 14(a). This gap appeared to result from buckling in the wall as indicated in Fig. 14(b). That is, the buckling pulled the whole western wall face longitudinally at W2. This did not cause any damage in the facing panels between W1 and W2, indicating that the reinforced wall system was highly flexible, and the large ground deformations were accommodated by the flexible joints of the facing panels.

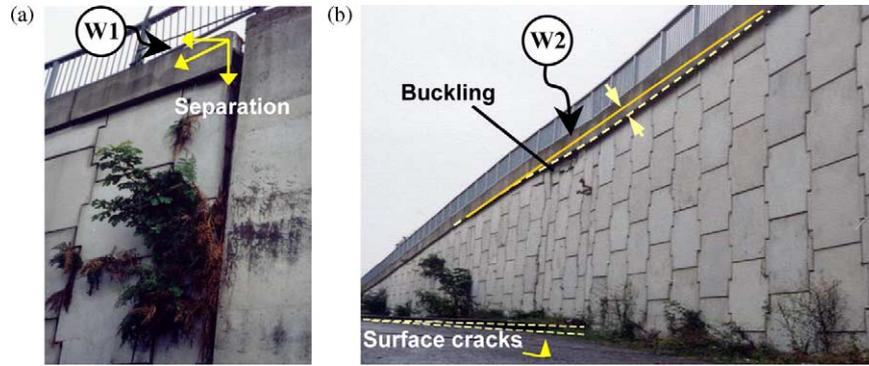
Fig. 14. Damage on the western MSEW face: (a) W1; (b) W2 (courtesy of M. Ozbakir).
