# Structural and geotechnical impacts of surface rupture on highway structures during recent earthquakes in Turkey

A. Pamuk<sup>a,\*</sup>, E. Kalkan<sup>b</sup>, H.I. Ling<sup>a</sup>

*Keywords:* Bridge; Kocaeli earthquake; Duzce earthquake; Seismic hazard; Retrofitting; Fault rupture; Arifiye Overpass; Mechanically stabilized earth wall

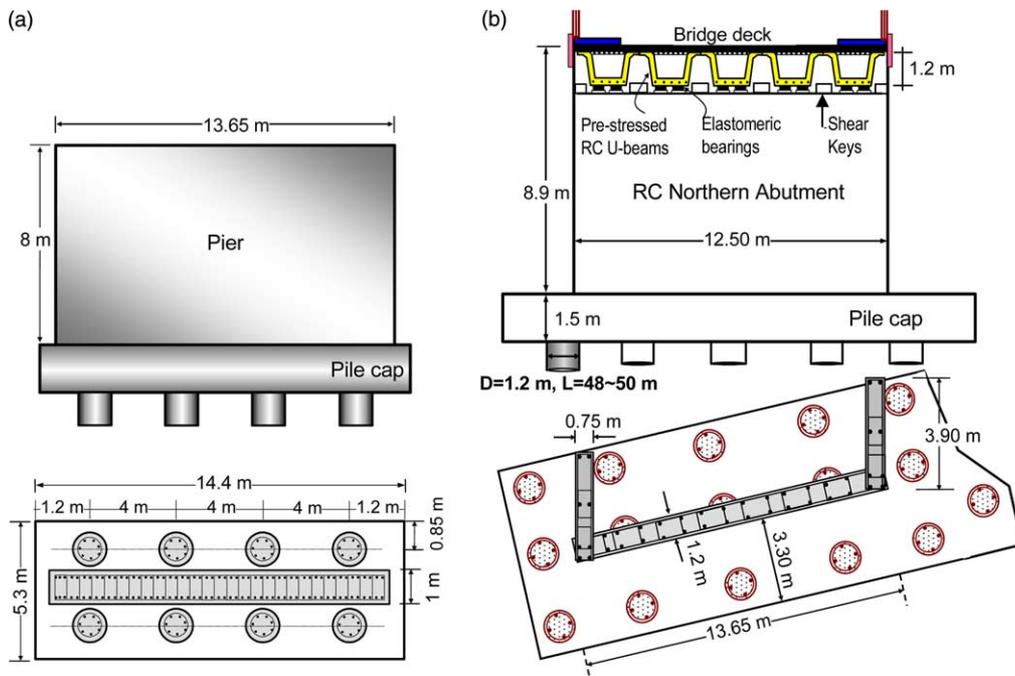
Fig. 7. Structural details of the bridge overpass at Arifiye: (a) detailing of bridge pier and pile foundation; (b) detailing of northern bridge abutment, deck and girders.

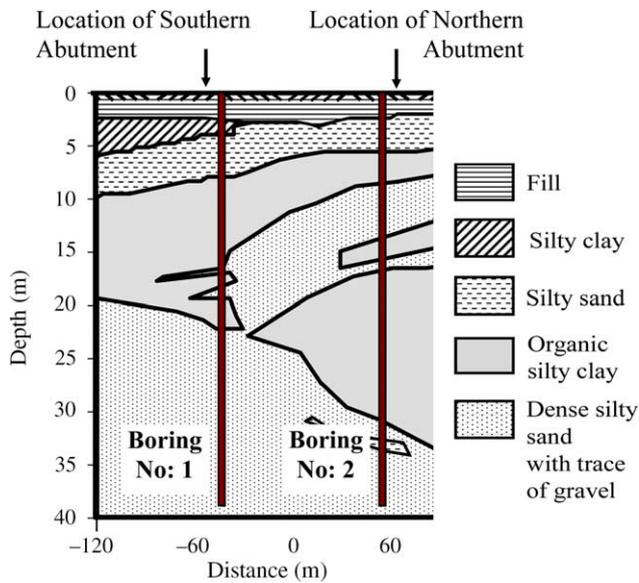
Fig. 12. Visualization of subsoil geology along the axis of Arifiye Overpass (modified based on [19]).

below the reinforced walls may have experienced liquefaction or seismic-induced densification during the seismic event.

These field measurements obtained after the earthquake may reflect denser states of the soil layers than those prior to the earthquake. Field observations revealed a number of factors that damaged the MSEW system in Arifiye. These include (i) large tectonic movements along the main fault line, (ii) the presence of a drainage culvert, (iii) near-fault effects, and possibly, (iv) cyclic loading-induced soil densification and settlement. Only the sections of the MSEW approach ramp between the bridge abutment and RC culvert, about 20 m long, was significantly damaged (Fig. 11(c)). The locations most affected by the damage along the eastern and western wall faces are highlighted in Fig. 11(b) as E1 and E2 (E: Eastern side), and W1 and W2 (W: Western side), while their detailed views are presented in Figs. 13 and 14. The right-lateral strike-slip fault rupture along the main fault line passed under the northernmost span of the bridge (Figs. 4 and 7) with large transverse and vertical displacements of approximately 3.5 and 0.5 m, respectively [5]. The vertical ground deformation appeared
